# Manhole Inspection Summary

Manhole # S39I\_\_040MH

Insp Date: **8/19/08 12:17 PM**

**Location** Address: **701 e pratt st**

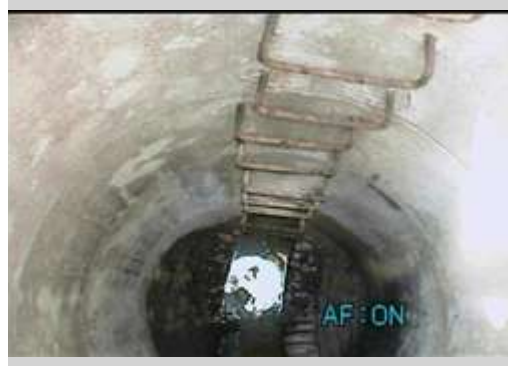
Top View

and steps

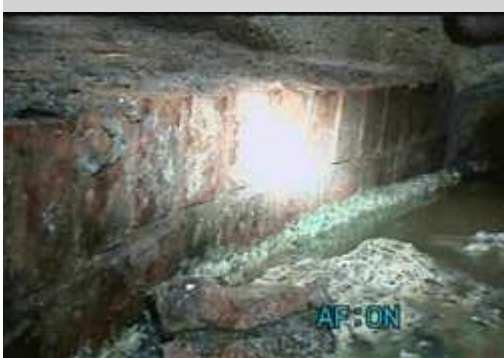
Defect 1

Condition: ☐ Sound ☐ Cracked ☐ Root Intrusion ☐ Deteriorated ☐ Leaks ☒ **Debris**

channel debris

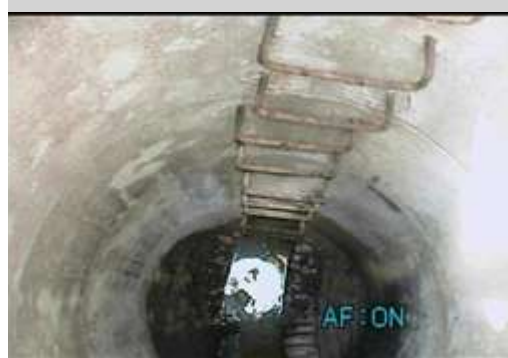
Defect 2

**Steps** Count: **10** Missing: **0** ☒ **Corroded**

Corroded steps

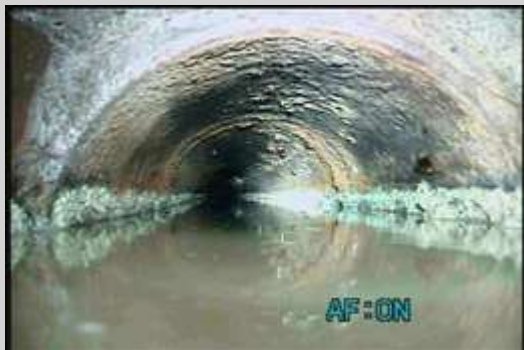
12 O'Clock Outflow

12 in. Circular Gravity Sewer  
Pipe Out @ 12 O'Clock

Pipe Material: **Clay** ☐ Pipe Lined

Invert Depth: **12.40** (ft.) Flow Characteristics: **Slow**

Infiltration: **None** Pipe Seal Cond: **Unknown**

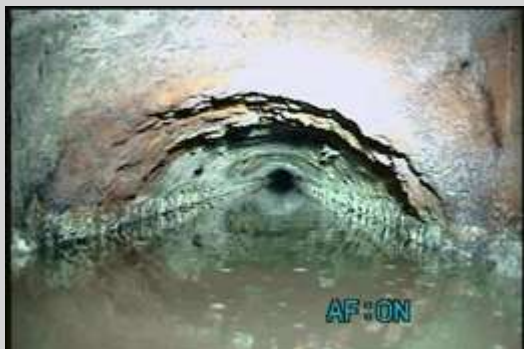
7 O'Clock Inflow

12 in. Circular Gravity Sewer  
Pipe In @ 7 O'Clock

Pipe Material: **Clay** ☐ Pipe Lined

Invert Depth: **12.30** (ft.) Flow Characteristics: **Slow**

Infiltration: **None** Pipe Seal Cond: **Unknown**
